CASE REPORT

Perivalvular pannus and valve thrombosis: Two concurrent mechanisms of mechanical valve prosthesis dysfunction

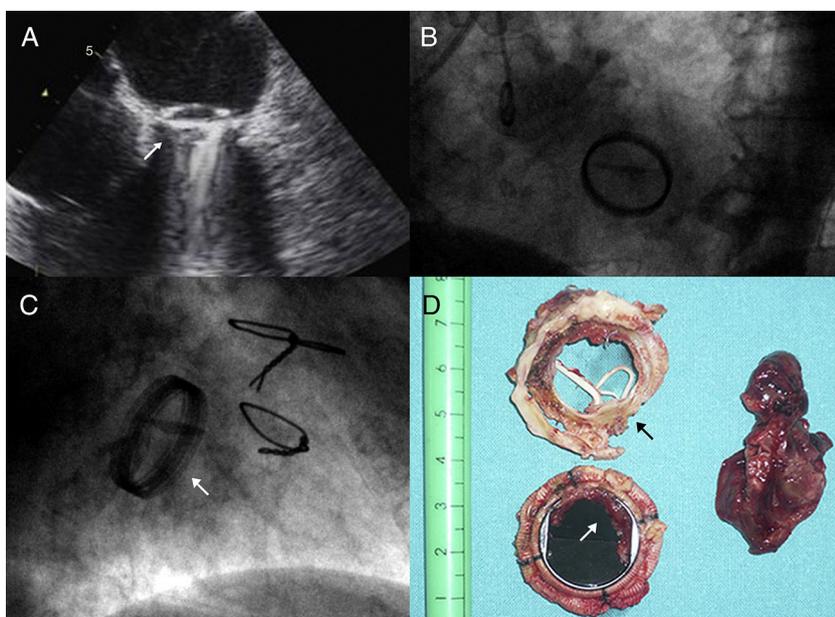
Figure 1 Transesophageal echocardiogram (A) and fluoroscopy (B and C) showing impaired motion of the two leaflets due to associated pannus and thrombosis; (D) explanted mechanical mitral valve. The shape of pannus growth on the ventricular surface of the prosthesis removed from the prosthesis can be clearly seen. The concentric stenosis of the valve orifice area (black arrow) and the thrombosis on the atrial side causing valve blockage (white arrow) are evident. The mural blood clot removed from the left atrial appendage is shown.

A 78-year-old woman with a history of hypertension and diabetes was admitted to our institution with a one-year history of progressive dyspnea. Ten years previously she had been diagnosed with rheumatic heart disease and atrial fibrillation and had undergone mitral valve replacement with a 25-mm Carbomedics bileaflet mechanical valve. She had been asymptomatic until two months ago, when she reported dyspnea (New York Heart Association class III), orthopnea, and weight gain. Physical examination revealed cardiac arrhythmia and signs of decompensated heart failure (ascites and lower limb edema). Laboratory tests showed no abnormalities. The electrocardiogram confirmed atrial fibrillation. An echocardiogram revealed restricted motion of the mitral leaflets (Figure 1A), with partial thrombosis of the mitral prosthesis and a blockage of the posterior mechanical prosthesis disc. A high transmitral gradient was observed by transesophageal echocardiography. A left atrial (LA) mural thrombus, moderately depressed left ventricular ejection fraction (45%), severe pulmonary artery hypertension (systolic pulmonary artery pressure of 70 mmHg), and severe functional tricuspid regurgitation were also detected. A coronary angiogram confirmed an immobile prosthetic leaflet (Figure 1B and 1C). No lesions were seen in the main coronary arteries. The patient was scheduled for cardiac surgery.

Through median sternotomy, adhesences from the previous surgery were carefully released. Cardiopulmonary bypass was established with bicaval venous cannulation. Through transseptal access, the mitral prosthesis was accessed and examined. Intraoperatively, a 3×3 cm thrombus was removed from the origin of the left atrial appendage (not closed during the first cardiac operation) and in immediate contact with the mechanical valve (Figure 1D). A partial thrombosis was observed around the mechanical valve and an immobile prosthesis disc was seen. The mitral prosthesis was replaced and the mechanical valve was excised, revealing circumferential mitral prosthesis obstruction due to pannus growing within the valve orifice on the ventricular surface of the prosthesis. The valve was replaced with a 31-mm Labcor mitral bioprosthesis and tricuspid annuloplasty was also performed. Echocardiographic monitoring confirmed that the mitral prosthesis was functioning correctly without leakage after placement. Postoperatively, the
