IMAGE IN CARDIOLOGY

Acquired mitral valve aneurysm due to severe aortic regurgitation

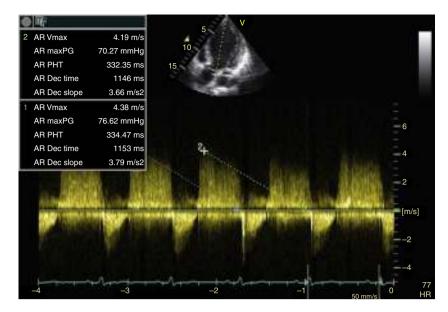
Figure 3 Continuous wave spectral Doppler recording through the aortic valve. Pressure half time is noted to be 334 ms.

with normal contraction. Severe aortic regurgitation (AR) and holodiastolic flow reversal in the abdominal aorta were present (Figures 1–4). No vegetation was seen on the aortic valve. There was an aneurysmal sac on the anterior leaflet of the mitral valve, corresponding to the site of the high velocity AR jet (video 1 and video 2 in the Supplementary material). Laboratory tests including complete blood cell count, liver and kidney function tests, erythrocyte sedimentation rate and C-reactive protein were normal. The patient refused surgical intervention and was lost to follow-up.

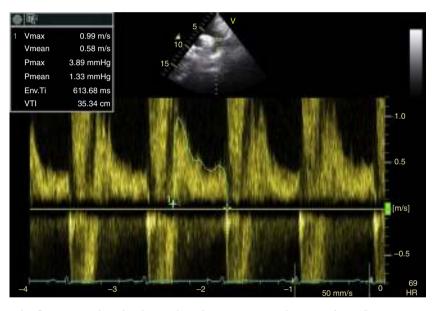
Figure 4 Holodiastolic flow reversal in the descending thoracic aorta indicative of significant aortic valve regurgitation.
