## IMAGE IN CARDIOLOGY

# Optical coherence tomography images of three different overlapping stents

Rosa Alba Abellás-Sequeiros\*, Raymundo Ocaranza-Sánchez, Ramiro Trillo-Nouche, José Ramón González-Juanatey

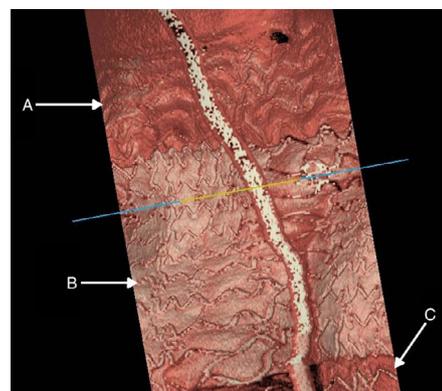
**Figure 1** (A) Bioresorbable strut; (B) polymer stent graft strut; (C) metal strut of the drug-eluting stent.

DES; this case is a good example on this characteristic. OCT images show the interface between the resorbable scaffold, the polymer layer of the stent graft and the metal strut of the distal DES (Figures 1 and 2). Figure 3 shows the stent graft overlapping the BVS.

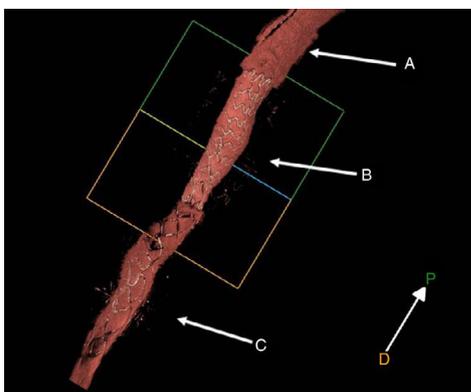
**Figure 2** (A) Bioresorbable strut; (B) polymer stent graft strut; (C) metal strut of the drug-eluting stent.

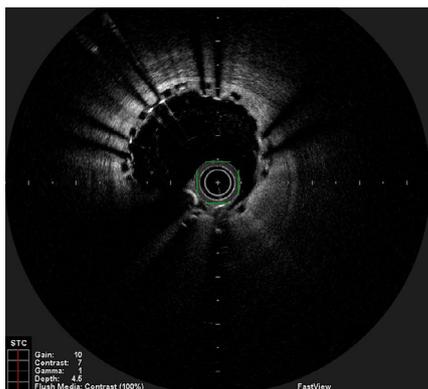
**Figure 3** Optical coherence tomography image showing bioresorbable vascular scaffold struts and distal overlapping of metal struts of the stent graft.
